型号: Arkbird 1.4W 433UHF (LoRa版本)

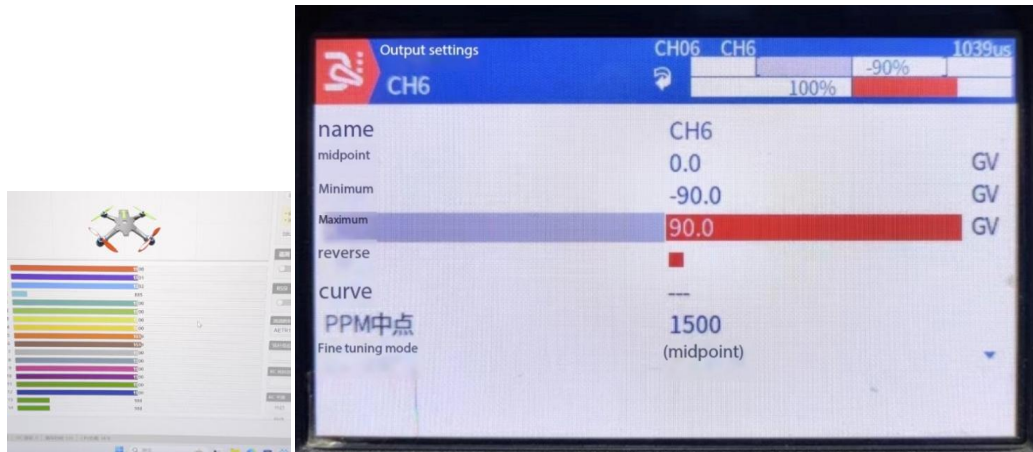
- 1) When using BF firmware, channels 1, 2, and 4 have no response, and can only be controlled after throttle CH3 reaches 10% or more;
- 2) The auxiliary channel cannot be controlled.

The above two points are due to the large rudder stroke (800-2200us) of Arkbird 433, which triggered the throttle protection of BF firmware. **Please set the value range position to 90%** on the remote control to solve the problem:
